# BASIC OPERATION GUIDE

## GFCI Receptacle

TMC PART NUMBER: 0375841

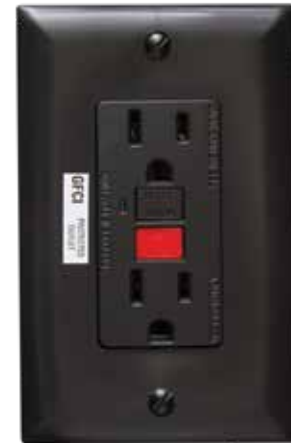
Typical GFCI receptacle

1. Make sure power is switched ON to the circuit. Use a test meter, test probe or a low-wattage electrical device.
2. PUSH the test button. The RESET button should pop out.
3. With the RESET button out, all power should be interrupted (OFF) to the recept being tested.

4. Verify there is no voltage to the recept by using the test probe or low-wattage electrical device.
5. Push the RESET button IN to restore power to the GFCI.
6. Verify that voltage has been restored to the GFCI recept.
